DEPARTMENT OF TRANSPORTATION**DIVISION OF ENGINEERING SERVICES**

Quality Assurance and Source Inspection

Contract #: 04-0120F4Cty: SF/ALA Rte: 80 PM: 13.2/13.9File #: 69.28**WELDING INSPECTION REPORT****Resident Engineer:** Pursell, Gary**Address:** 333 Burma Road**City:** Oakland, CA 94607**Report No:** WIR-009437**Date Inspected:** 06-Oct-2009**Project Name:** SAS Superstructure**OSM Arrival Time:** 700**Prime Contractor:** American Bridge/Fluor Enterprises, a JV**OSM Departure Time:** 1900**Contractor:** Zhenhua Port Machinery Company, Ltd (ZPMC), Changxing Island **Location:** Shanghai, China**CWI Name:** Chen Xi**CWI Present:** Yes No**Inspected CWI report:** Yes No N/A**Rod Oven in Use:** Yes No N/A**Electrode to specification:** Yes No N/A**Weld Procedures Followed:** Yes No N/A**Qualified Welders:** Yes No N/A**Verified Joint Fit-up:** Yes No N/A**Approved Drawings:** Yes No N/A**Approved WPS:** Yes No N/A**Delayed / Cancelled:** Yes No N/A**Bridge No:** 34-0006**Component:** OBG Crossbeams**Summary of Items Observed:**

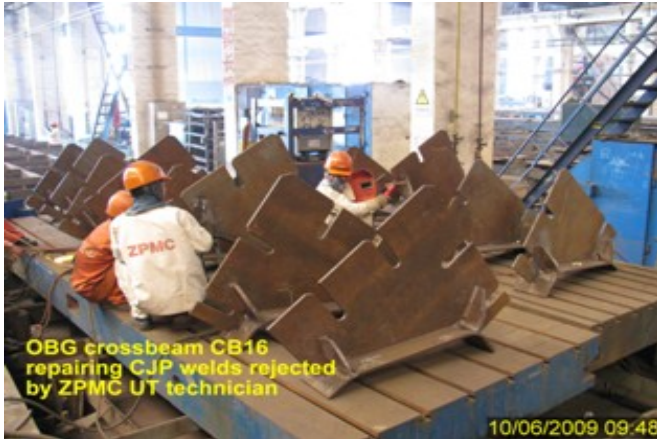
This QA observed the contractors welding personnel identified as 205390, 217185 and 066268 performing Complete Joint Penetration (CJP) weld repairs on welds that have been rejected by the contractors Quality Control (QC) Ultrasonic Testing (UT) technicians. The contractors QC inspector identified as Mr. Zheng Zhi Wei informed this QA that the repairs were being performed in conformance with WPS-345-SMAW-2G (2F)-repair and WPS-345-FCAW-2G (2F)-repair. This QA noted that the contractor had not performed Magnetic particle Testing (MT) of the excavated areas prior to welding as specified in the repair WPSs on the following repaired weld joints: FB205-051-043, FB205-049-006, FB205-050-046, FB205-052-005 and 006. The contractors repair WPS #WPS-345-SMAW-2G (2F)-repair and WPS-345-FCAW-2G (2F)-repair specifies "Grind all repair areas to bright metal and perform Magnetic Particle Testing prior to the start of welding". This QA notified ZPMC QC inspector identified as Mr. Zheng Zhi Wei and ABF QA inspector identified as Mr. Yu Kum Ming of the above mentioned issue and that an incident report would be generated.

This QA observed the following CJP welds have been excavated in preparation for repair: FB205-052-013 and 016, FB205-050-005, FB205-049-005, FB205-051-009, FB205-052-021, FB205-051-016 and 019, FB205-049-016, FB205-050-025, 031 and 034 and FB205-049-031 and 034. These welds were not included in the above mentioned incident report due to the fact that these repairs have not yet been welded and ZPMC QC inspector identified as Mr. Zheng Zhi Wei informed this QA that ZPMC would perform the required MT on these excavations prior to completing the repair welds.
